# Manhole Inspection Summary

Manhole # S17OO1004MH

Insp Date: **11/30/07 9:57 AM**

**Location** Address: **YELLOWWOOD AVE**

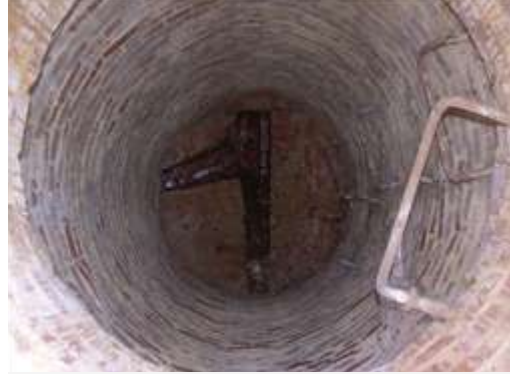
Top View

Bench and Channel debris.

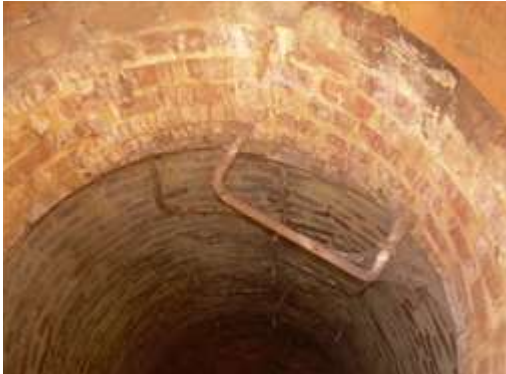
Defect

☒ **Leaks**

Condition: ☐ Sound ☐ Cracked ☐ Root Intrusion ☐ Loose Brick ☒ **Deteriorated**

Infiltration: ☐ None ☒ **Joint** ☐ Cracks ☐ Mortar ☐ Roots ☒ **Wall**

Frame leaks. Adjustment deterioration and infiltration.

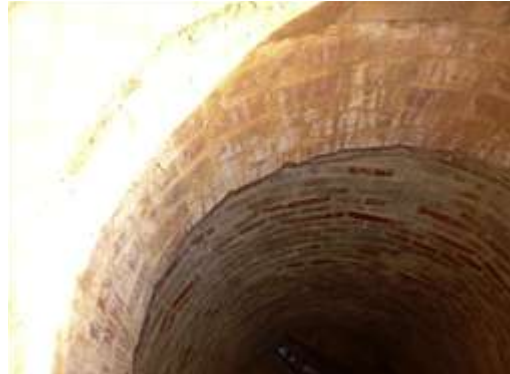
Defect

Frame leaks. Adjustment deterioration and infiltration - other side.

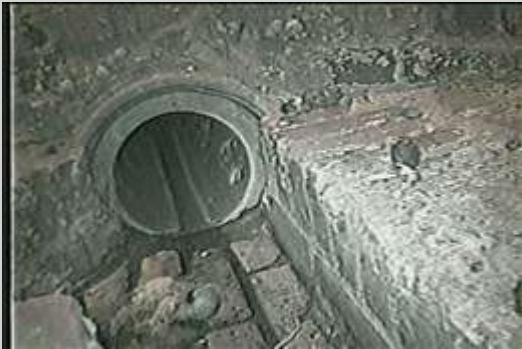
### 8 in. Circular Gravity Sewer Pipe Out @ 12 O'Clock

Invert Depth: **11.92** (ft.) Flow Characteristics: **None**

Infiltration: **None** Pipe Seal Cond: **Unknown**

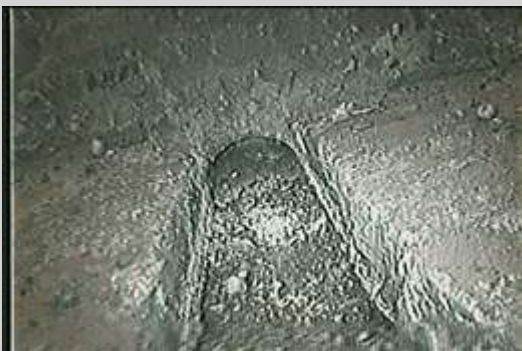
### 8 in. Circular Gravity Sewer Pipe In @ 6 O'Clock

Invert Depth: **11.66** (ft.) Flow Characteristics: **None**

Connects To: **Stub connection / abandoned**

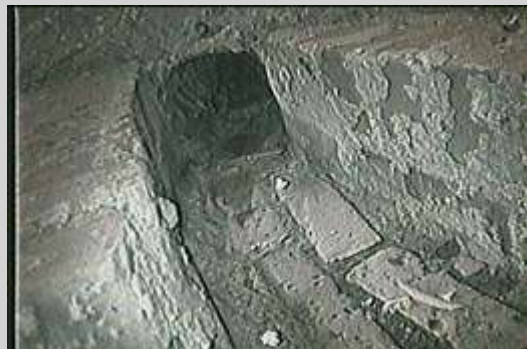
Pipe In @ 9 O'Clock

Invert Depth: **11.61** (ft.) Flow Characteristics: **None**

Infiltration: **None**
